Reconnaissance Inspection: Municipality of San Juan Municipal Separate Storm Sewer System (“MS4”) Permit (PRR040036)

PRASA Puerto Nuevo Wastewater Treatment Plant Collection System (PR0021555)

Inspection Date: February 16, 2012

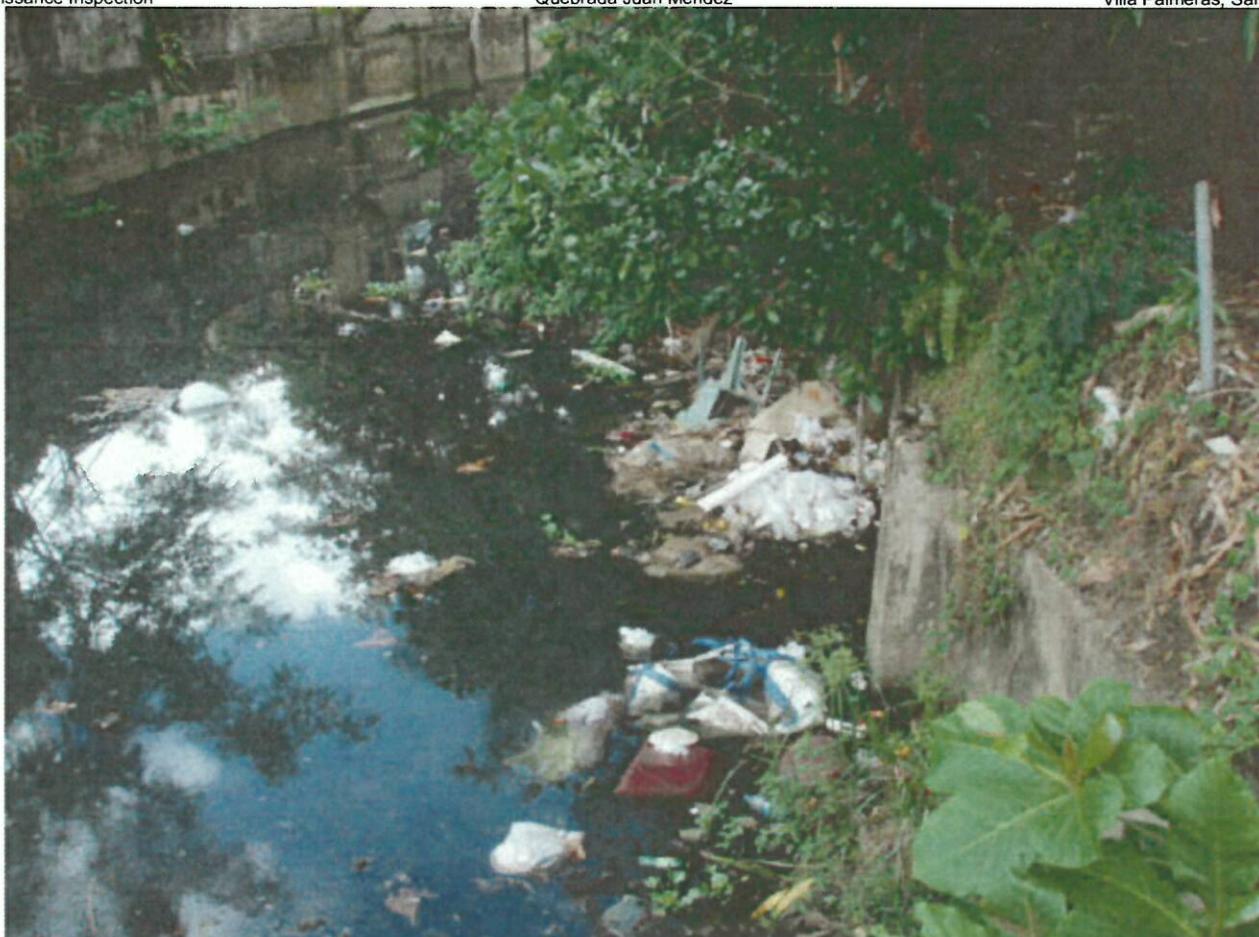
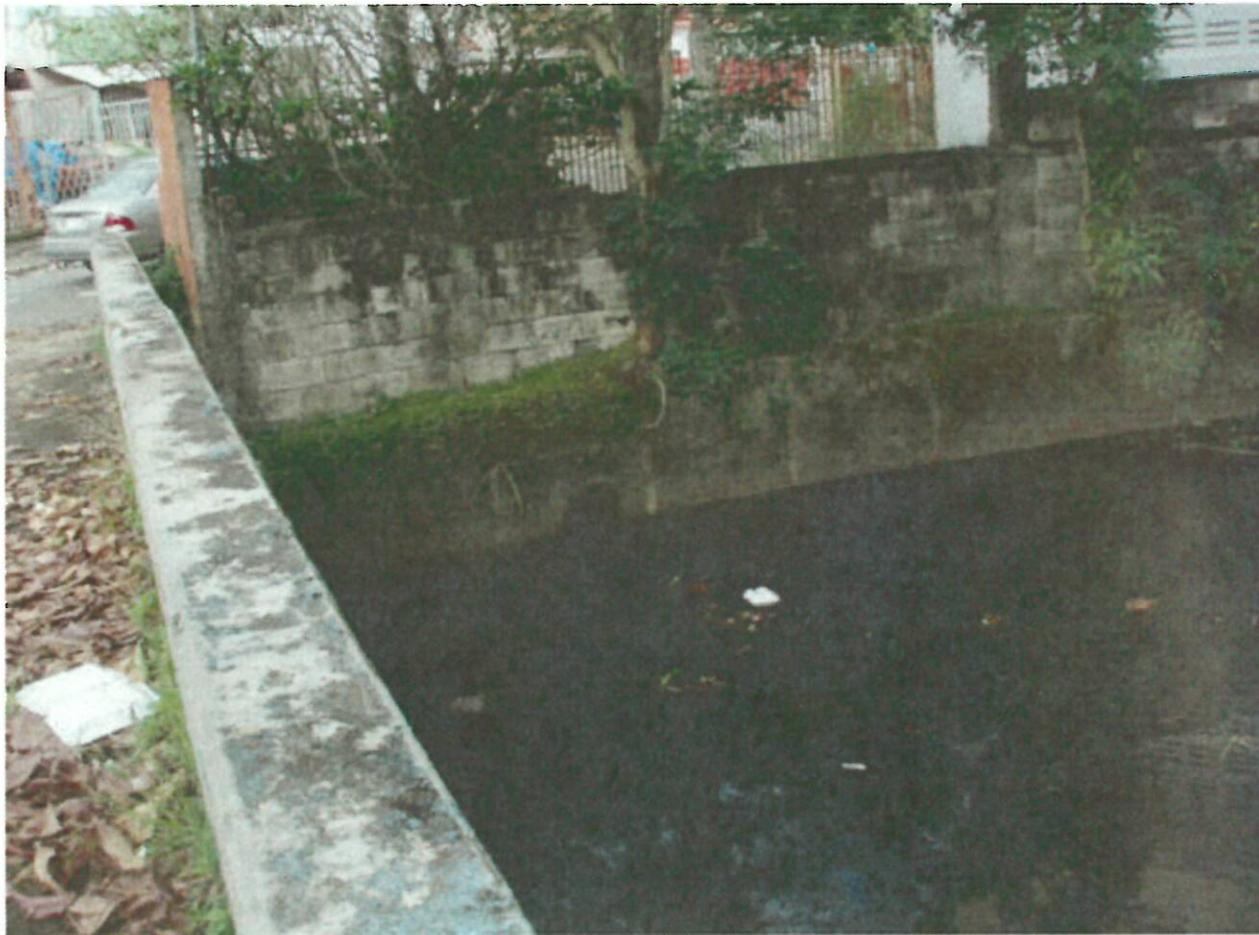
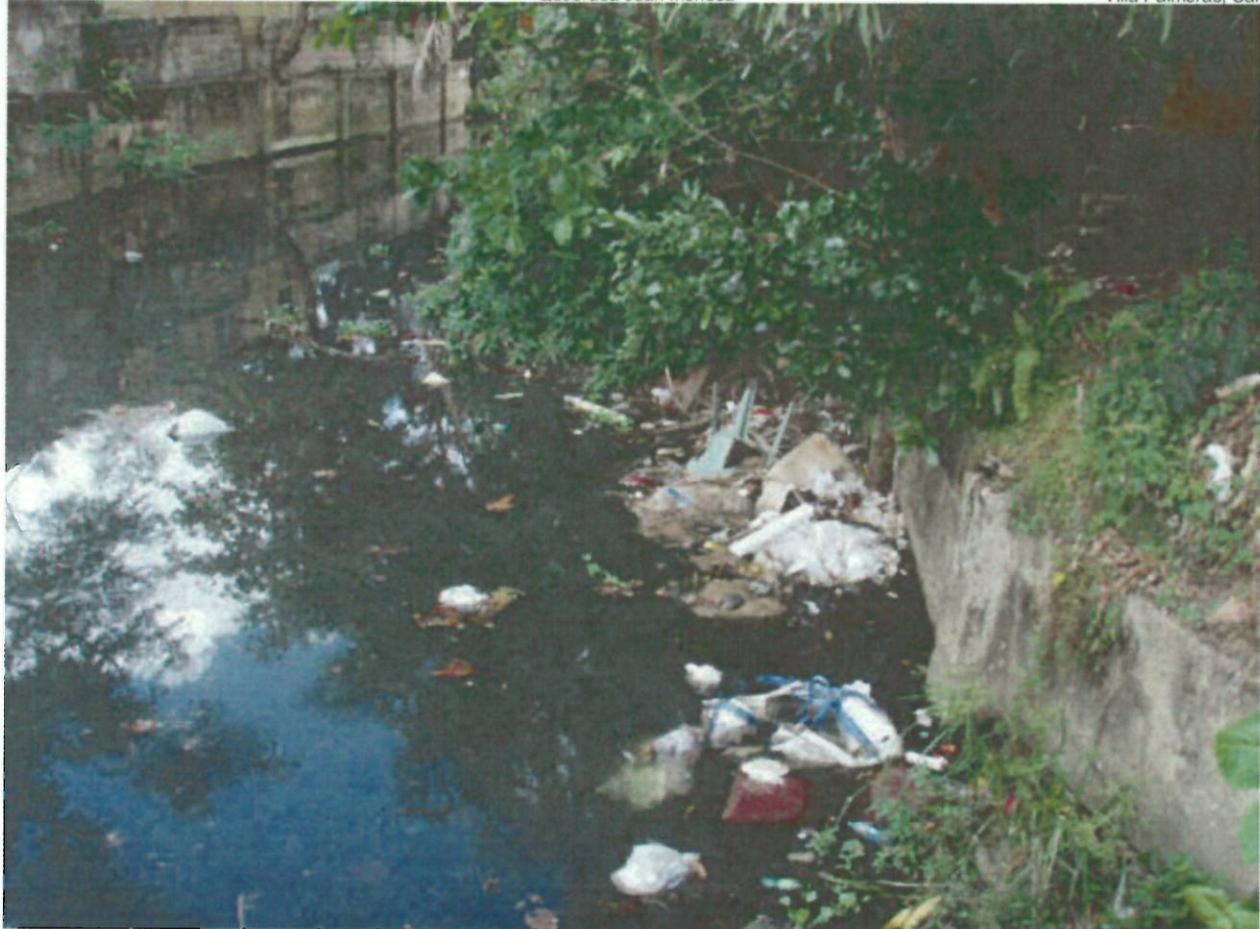
1. Calle Vergel and Calle Alcaniz - As shown in photograph P2160200 ("200") through 202 there is garbage and debris in Quebrada Juan Méndez that should be removed. The inspectors did not hear or see a dry weather discharge at this location. However, as described in attachment 3a-1, the 2009 CSA report identified a 24" outfall at this location, CSA No. L12c-S001a with a suspected sewage flow. Bubbles associated with anaerobic decay were seen rising to the surface in the Quebrada.

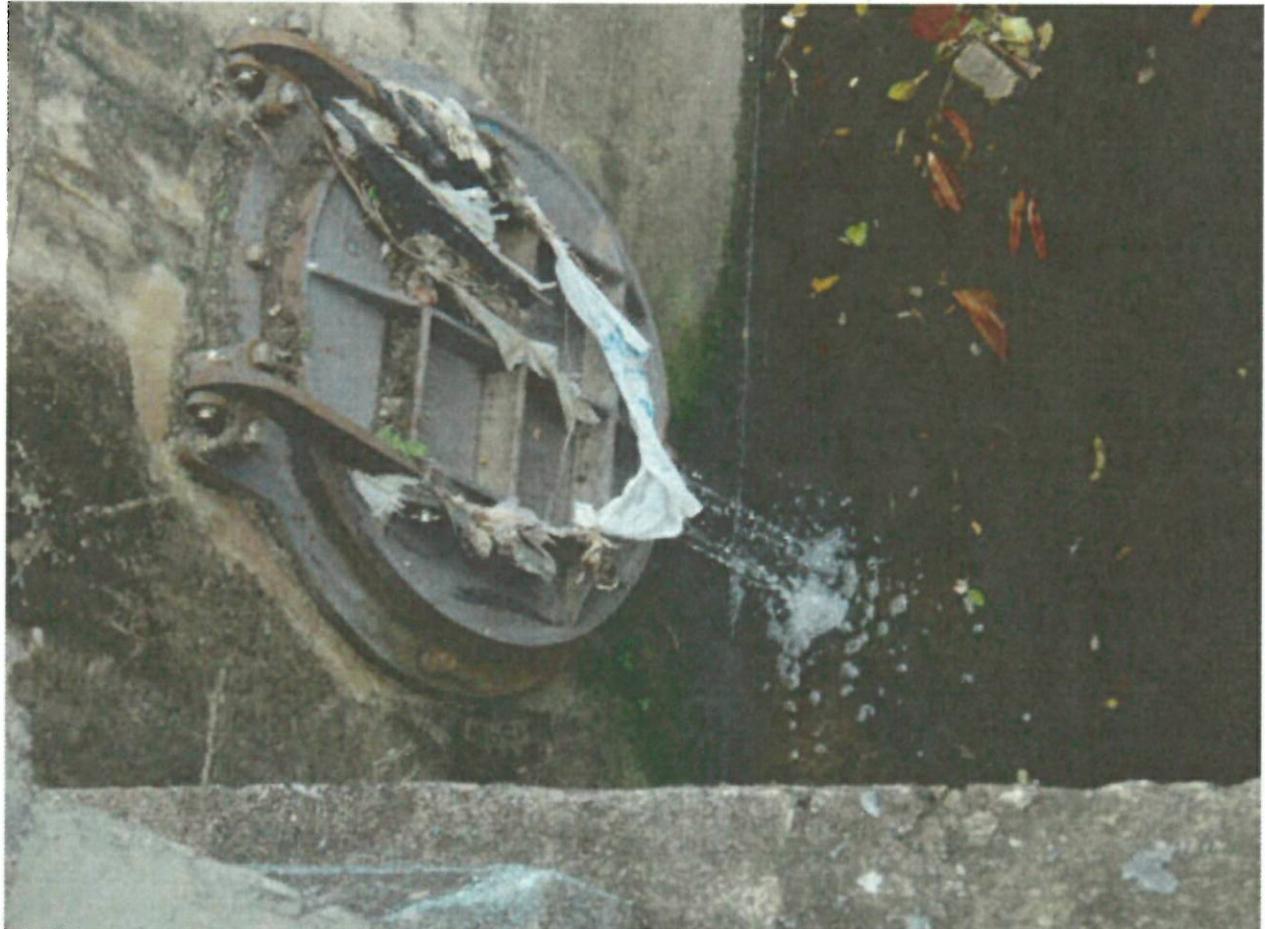
P2160203.JPG

2. Quebrada Juan Méndez and Calle Sicilia (Oriente) facing south upstream. As shown in photograph 203 there was a dry weather discharge from the circular pipe with a flapper valve that was seen on the east side of the Quebrada. (See Attachment 3a-2 for sanitary and storm sewer maps of this area).

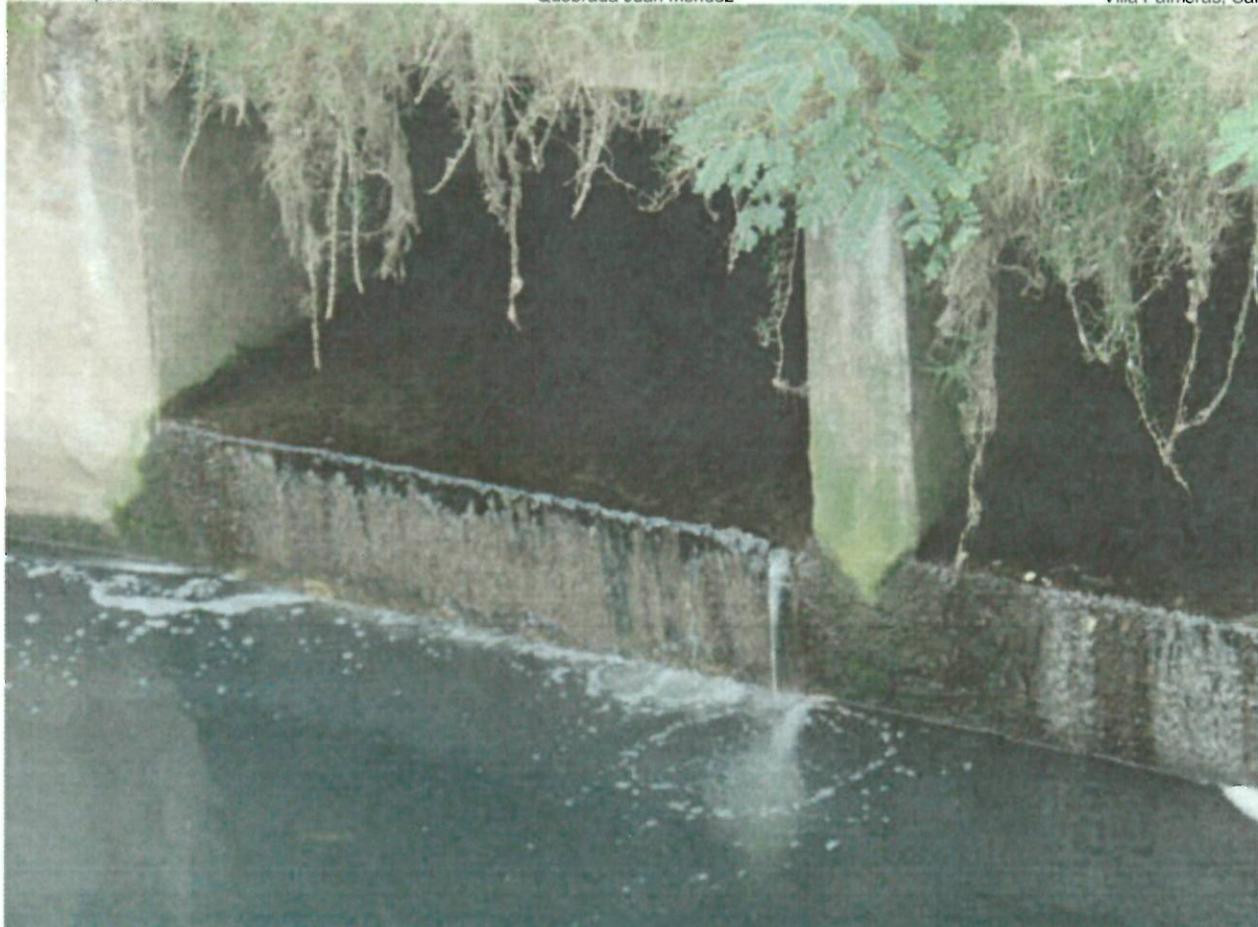
P2160206.JPG
02/16/2012

3. Calle América and Ramal Quebrada Juan Méndez (facing north side of bridge) (East of Barbosa Ave – Adjacent to Fire Station) – K13b-S002a. As shown in photograph 206 in Attachment 1 and the 2009 CSA report (Attachment 3b), there is a double box culvert with a dry weather flow that appears to contain sewage. There was some foaming in the Quebrada at the discharge point. EPA took a grab sample which had a slight sewage odor, and had an ammonia concentration of 3 mg/l and a pH of 6.5 to 7.0. While the ammonia test was not done with a 40 CFR Part 136 approved method, the 3 mg/l is an indicator that sewage is present.

The firemen at the station said that approximately 2 weeks prior to this inspection there was a fish kill in the Quebrada.. The firemen said that approximately 20 fairly large fish were seen dead in the Quebrada near the fire station and that representatives from the Puerto Rico Department of Natural and Environmental Resources conducted an investigation.

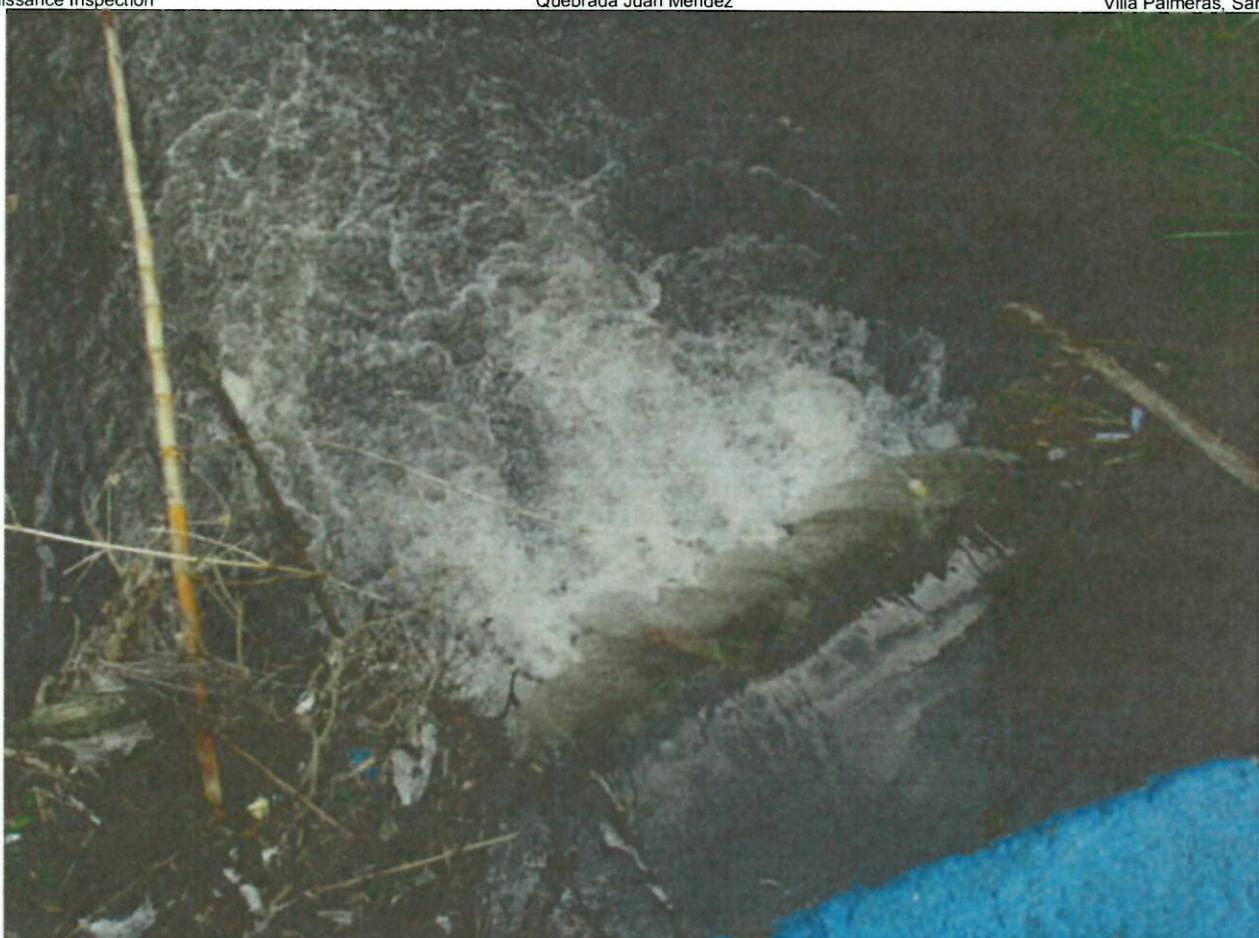
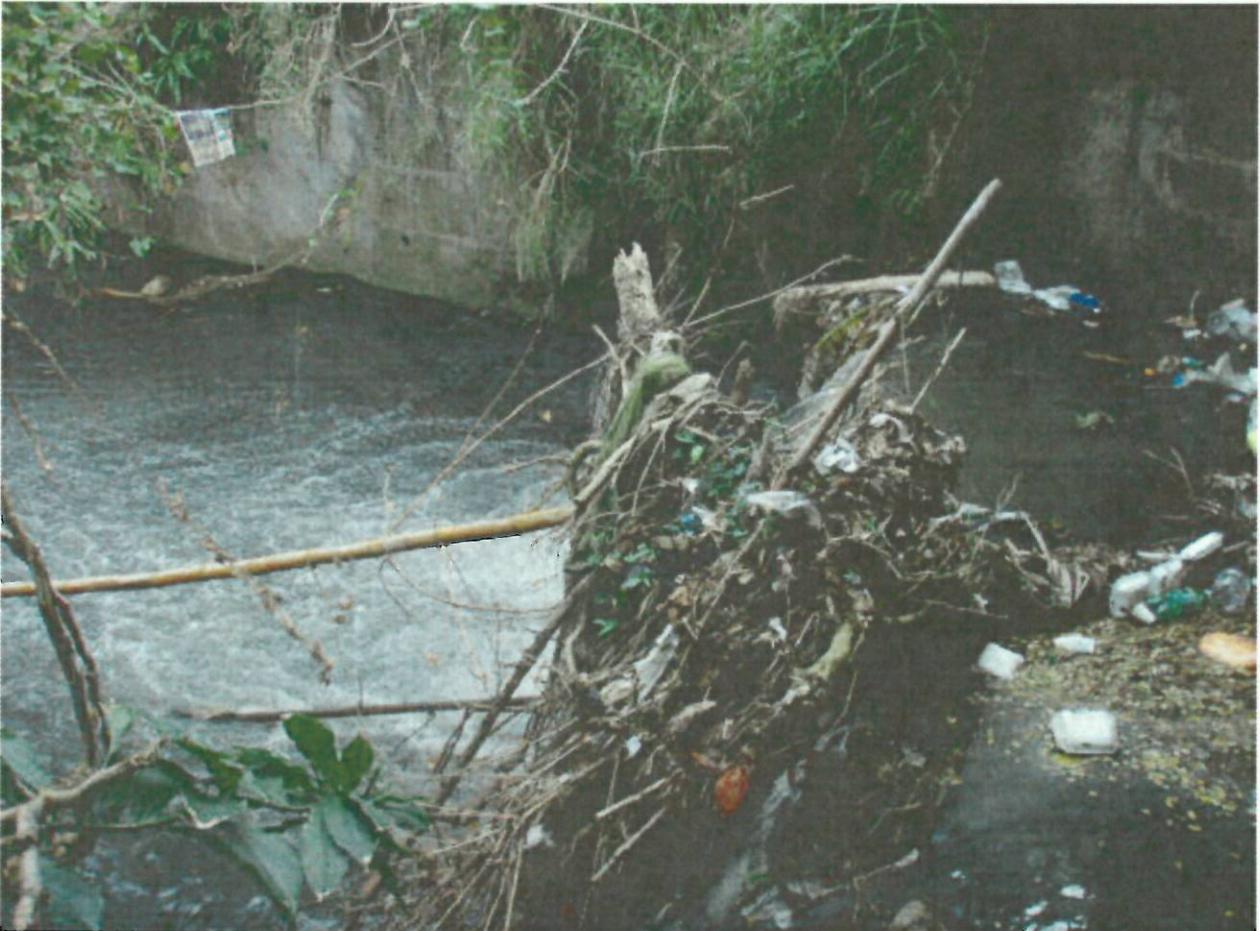
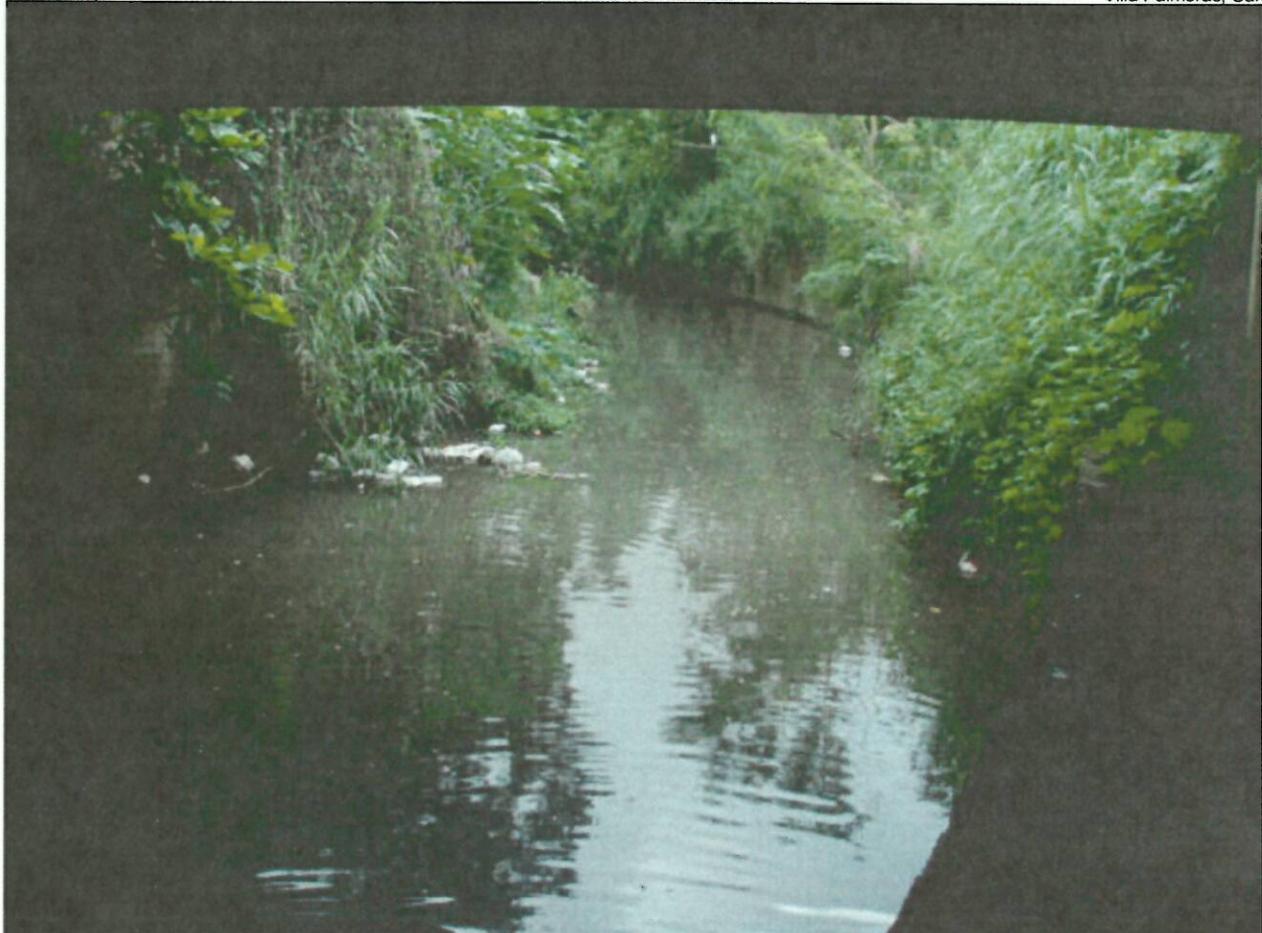
did not have a sewage odor; however the Quebrada Juan Méndez did have a sewage odor at this location (see photos 208, 211, and 212). MSJ and PRASA must conduct further review of this outfall to determine the source(s) of the flow.

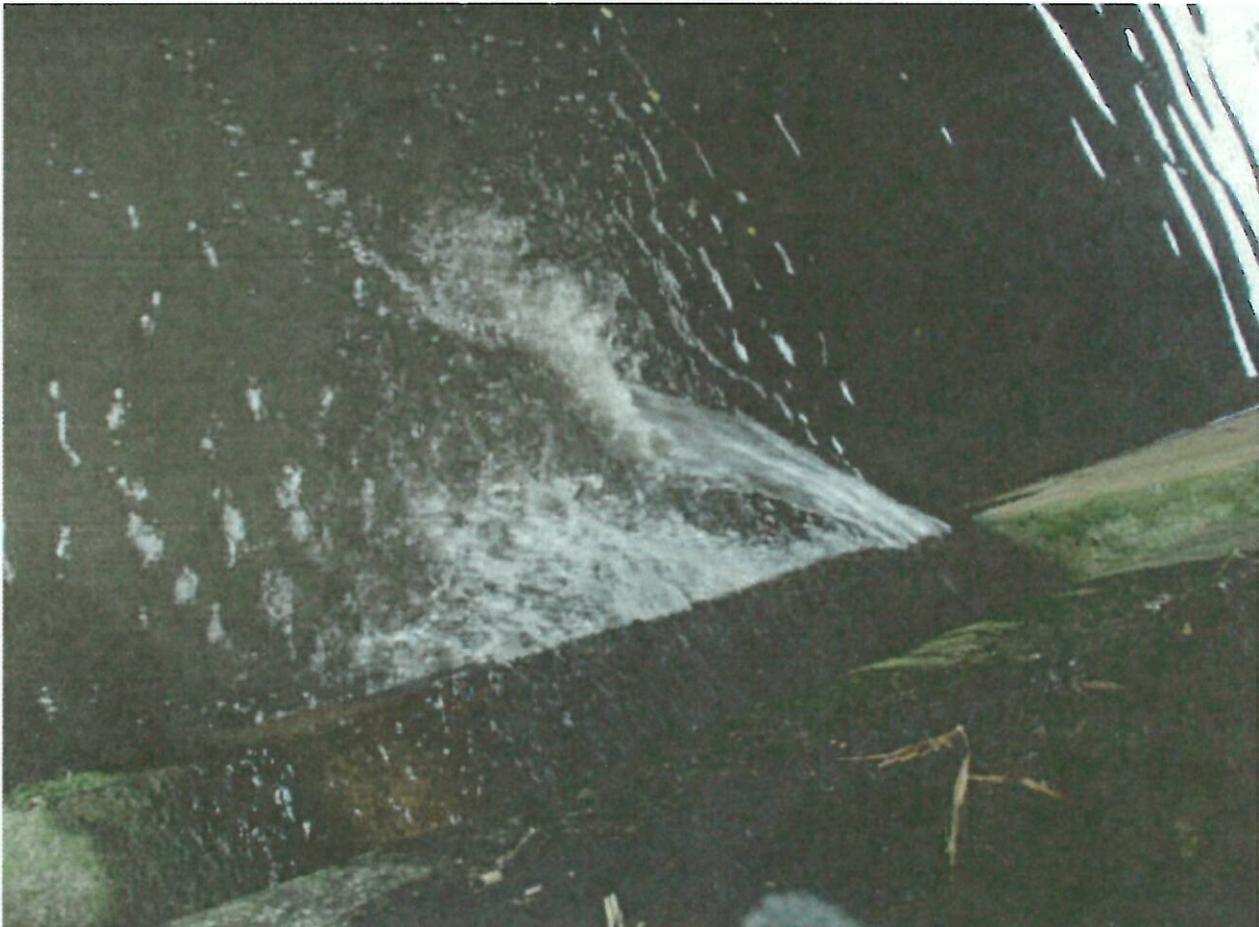
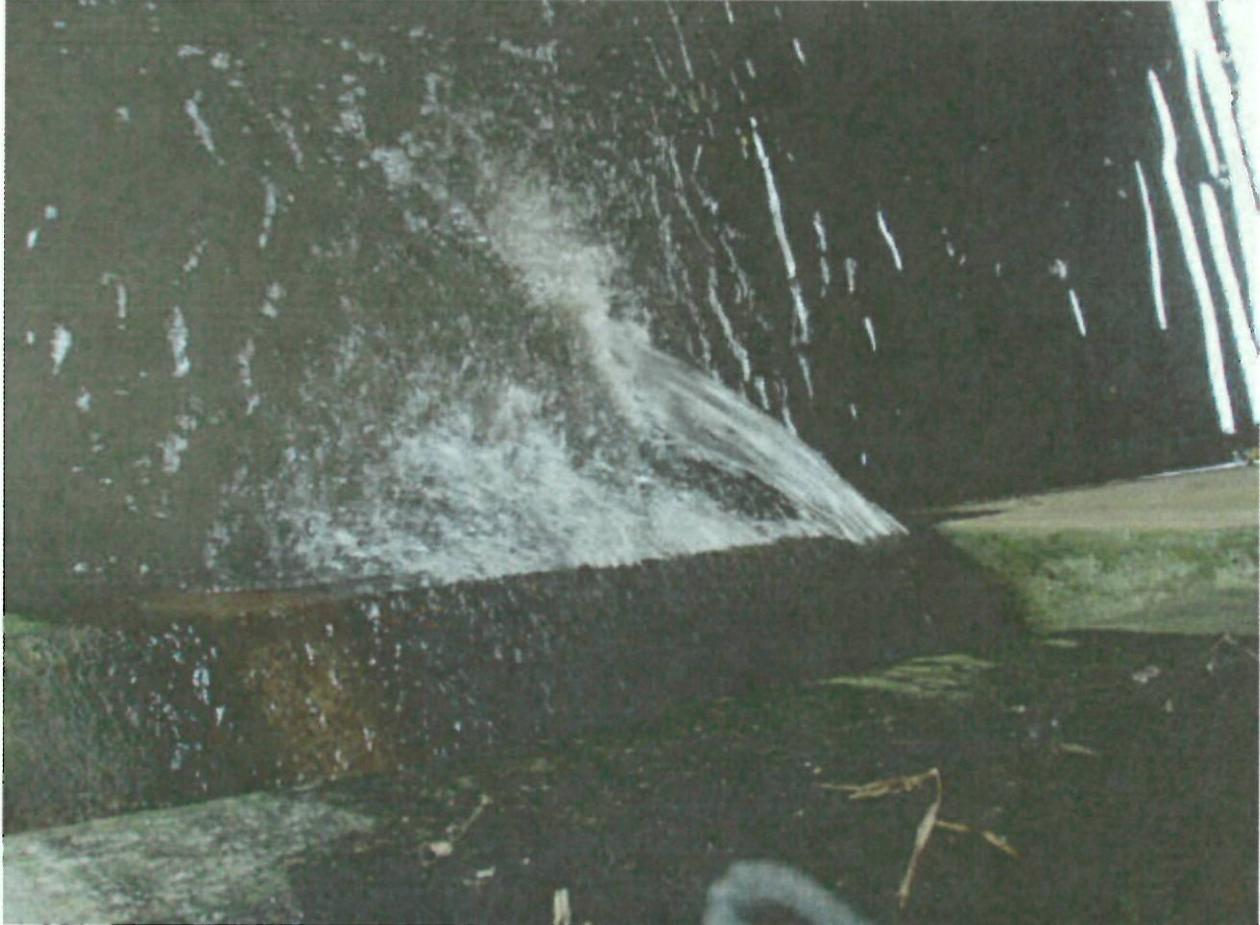
4. Calle Cruz (below the bridge) and Quebrada Juan Méndez - L15c-S001a Oriente/Valencia - As shown in photographs 209 and 210 there was flow from the Calle Cruz box sewer (6' X 3') below the bridge on Calle Cruz, at the west bank of the Quebrada Juan Méndez. As described in the 2009 CSA reports, Attachment 3c, this location was thought to be discharging sewage. EPA took a field sample and ammonia levels were approximately 0.25 mg/l and the pH was 6.5 to 7.0. The sample

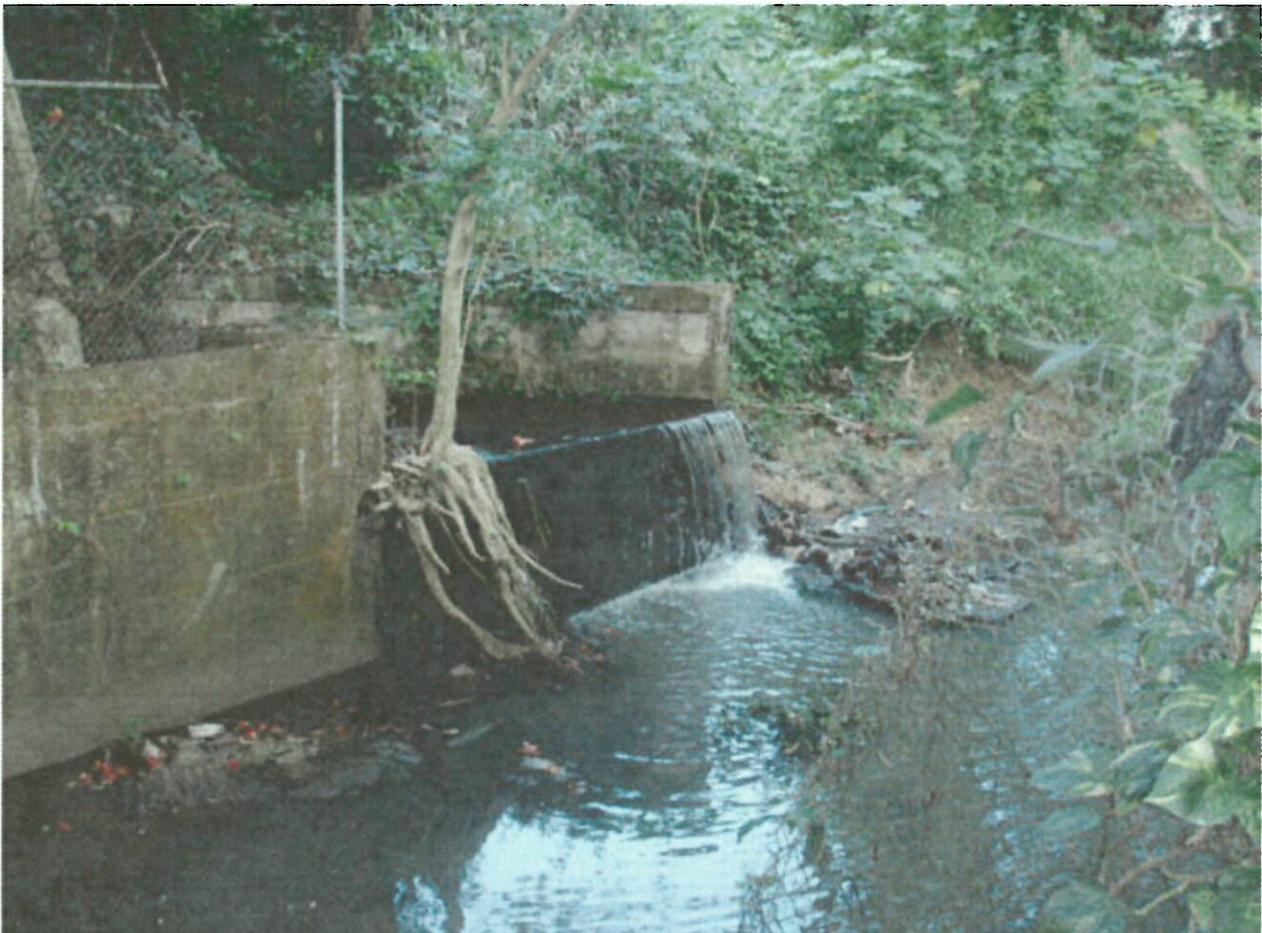
P2160213.JPG

As shown in photograph 213 there was a significant flow from a rectangular channel on the west side of Quebrada Juan Méndez across from Calle Ariel. The source of this flow as well as the water quality (and whether it contains authorized or illicit discharges), and ownership information, must be assessed. A map of the San Juan MS4 and PRASA Sanitary System is shown in Attachment 3e.

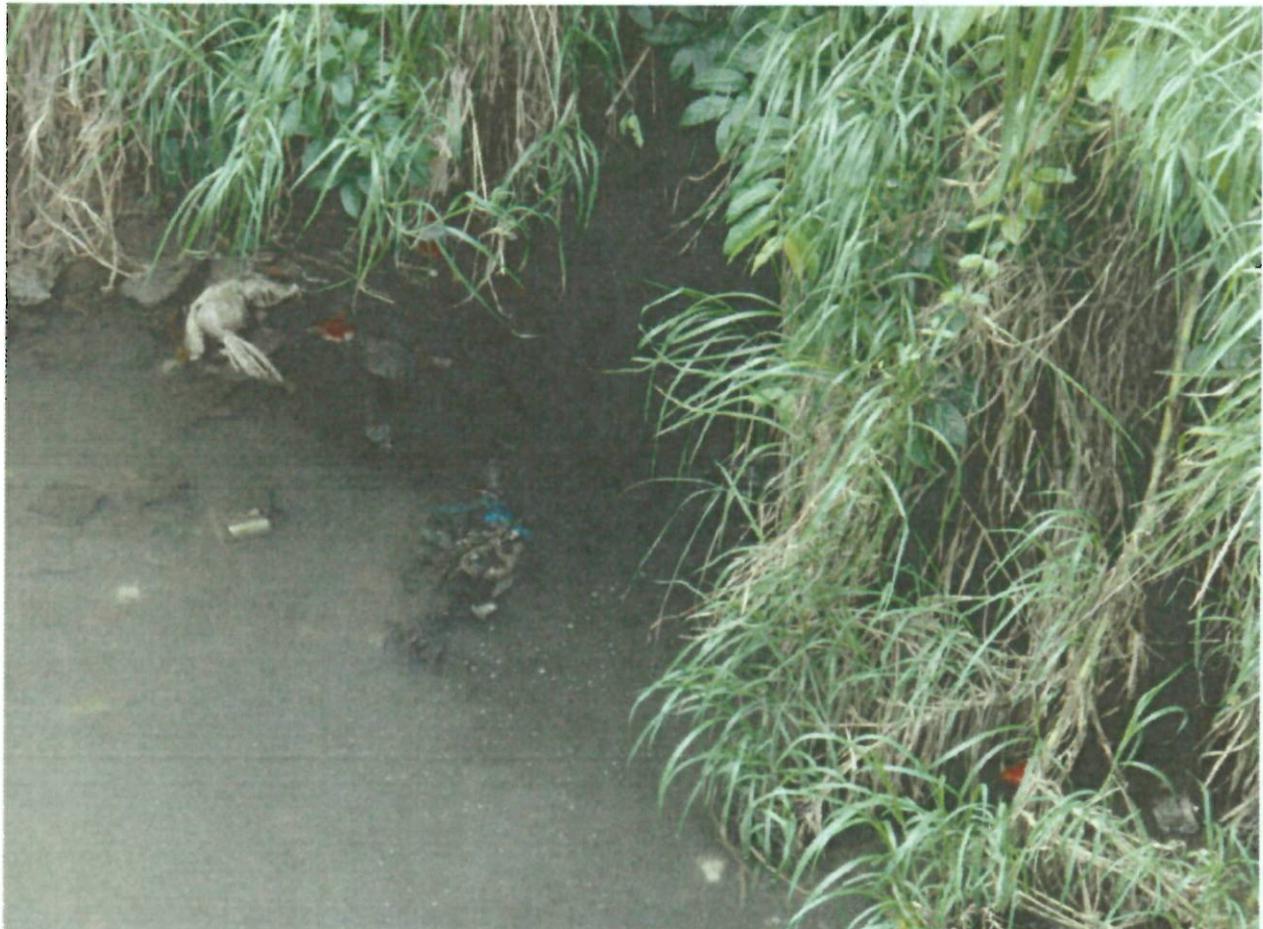
P2160215.JPG
02/16/2012

As shown in photographs 215 there was a dry weather discharge from this outfall. EPA was not able to obtain a sample of this discharge. As described in the CSA reports, attachment 3f, CSA recommended that this discharge be assessed for possible sanitary connections. As shown in photograph 216 it appears that the concrete channel walls had collapsed into the Quebrada. The collapsed walls can restrict flow in the Quebrada as well as lead to erosion of the banks.

P2160215	Calle Ramón B. López and Quebrada Juan Méndez L17a_S001a facing south (upstream) outfall discharging on west side of creek.

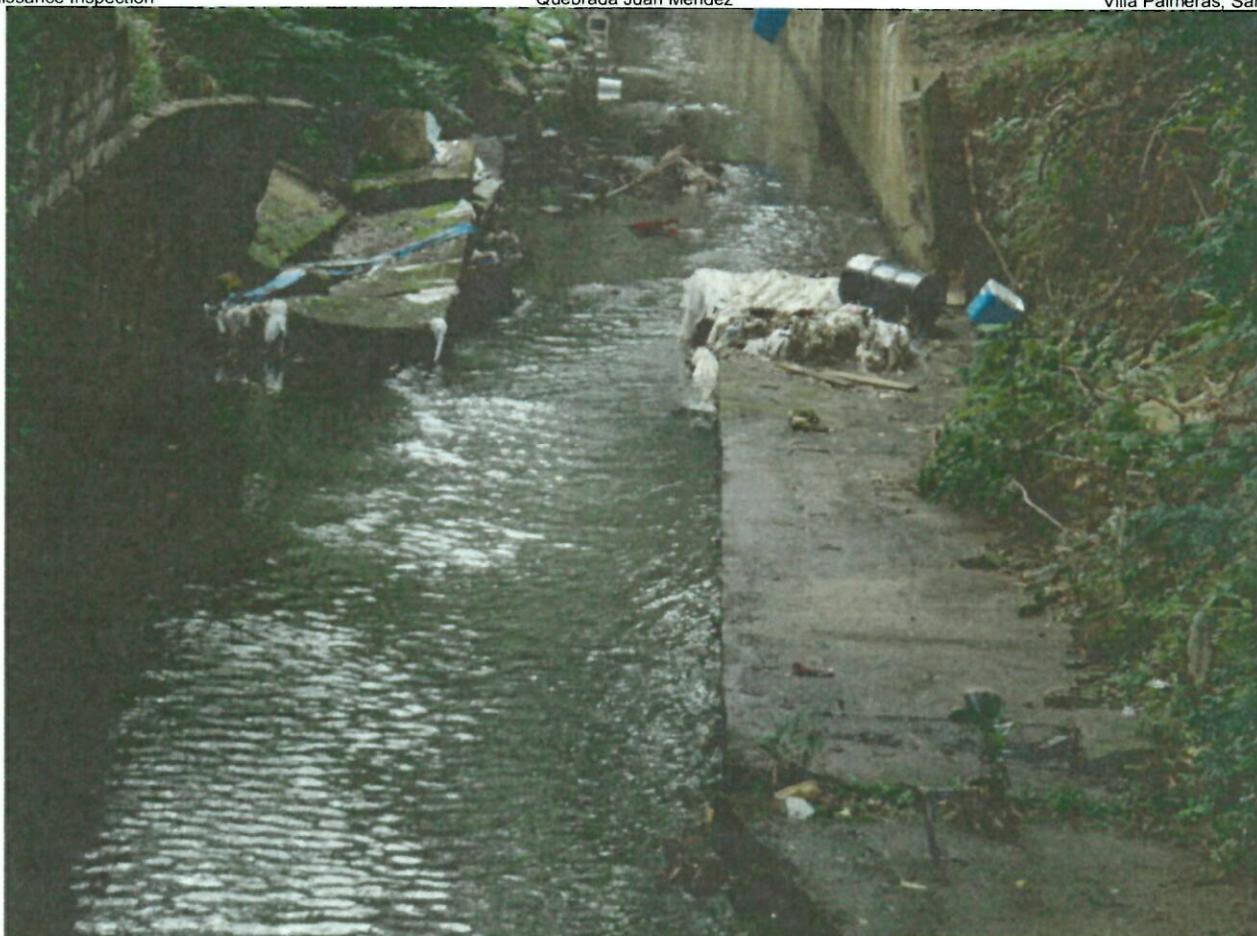
P2160216.JPG
02/16/2012

P2160216	Calle Ramón B. López and Quebrada Juan Méndez L17a_S001a the channel walls of the Quebrada have collapsed into the stream.
P2160217	Calle Ramón B. López and Quebrada Juan Méndez L17a_S001a facing south (upstream) outfall discharging on west side of creek.
P2160218	Discharge point at Calle Lealtad and José De Diego into west branch of Quebrada Juan Méndez - Discharge point flows from Stormwater Catch Basin - There was a dry weather discharge of sewage that was flowing onto the street and entering the catch basin.
P2160219	Discharge point at Calle Lealtad and José De Diego into west branch of Quebrada Juan Méndez - Discharge point flows from Stormwater Catch Basin - There was a dry weather discharge of sewage that was flowing onto the street and entering the catch basin.
P2160220	Sewage flowing out of Lealtad street/near Ave. José De Diego and into a stormwater catch basin which flows to Quebrada Juan Méndez - approx 30' away.

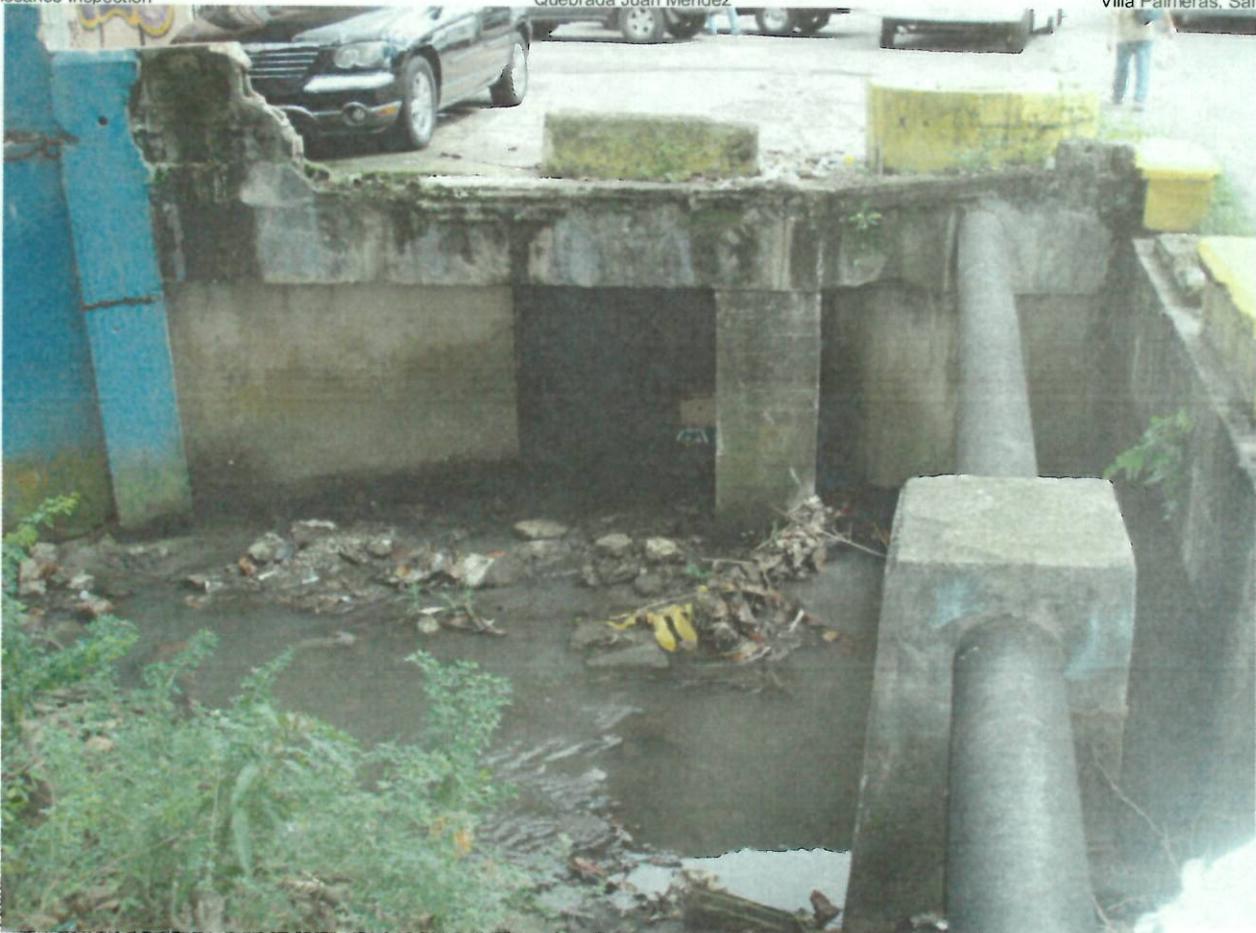
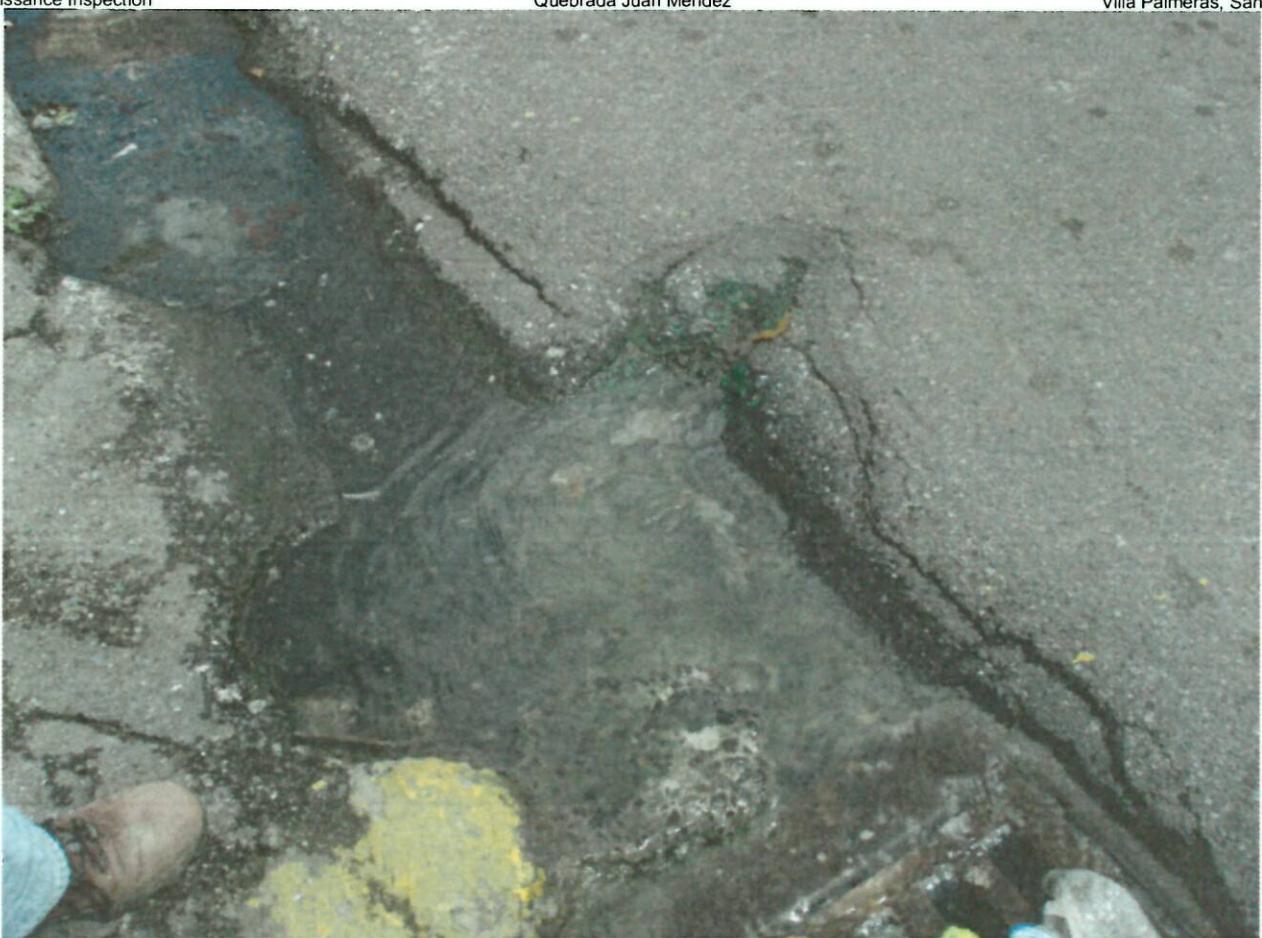
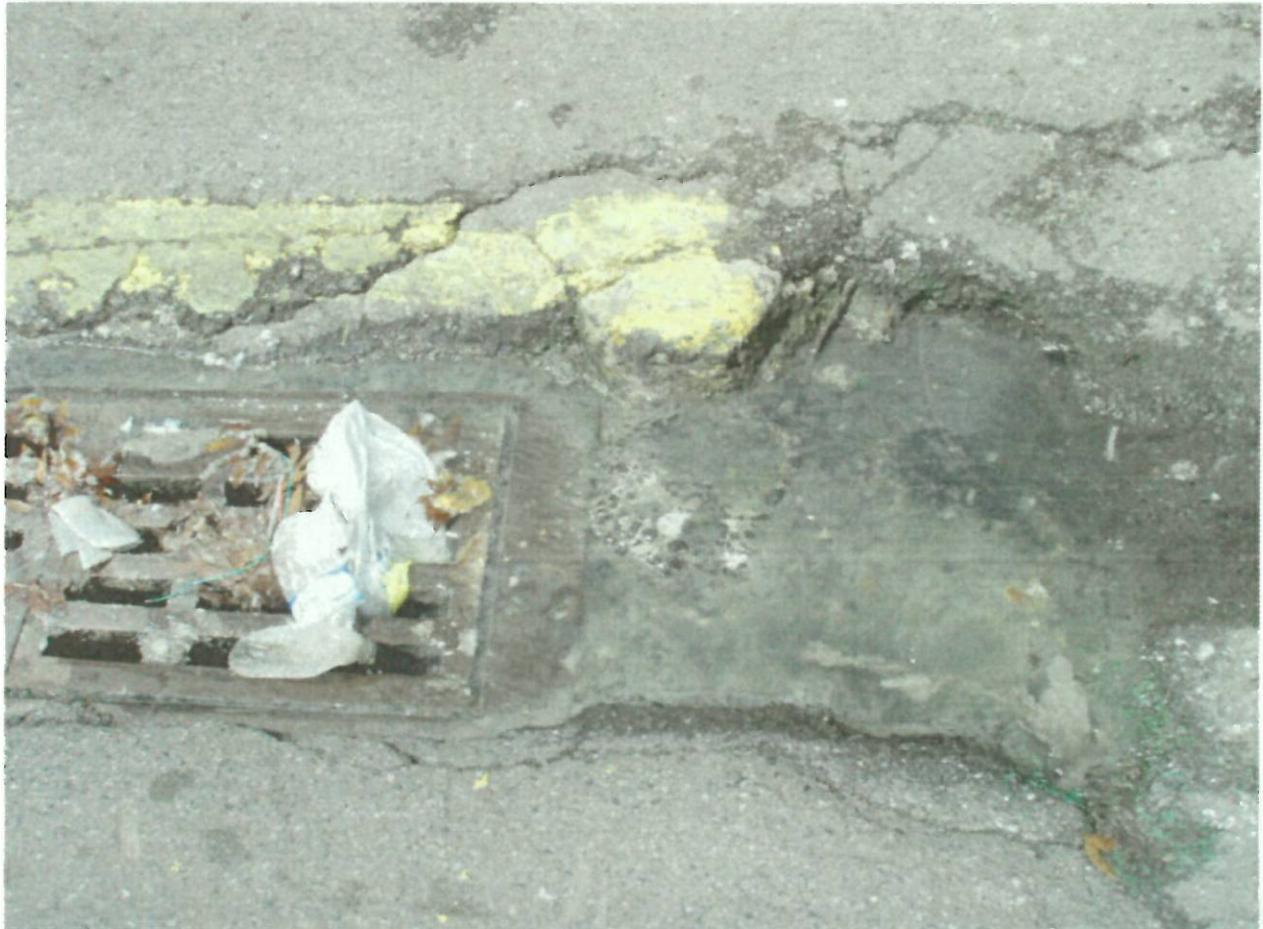
8. Calle Lealtad and José De Diego (PR-47) Just East of East Branch of Quebrada Juan Méndez, Río Piedras PR (Also East of Calle Alomar) – As shown in photographs 218, 220, 220, 223, and 225 water was flowing out of the street, just adjacent to the surcharged sanitary sewer manhole (which was full of wastewater, nearly, up to the top of the manhole) as shown in photograph 228. Sanitary and Storm Sewer maps for this location are contained in attachment 3g. The water flowing out of the street had a strong sewage odor and had an ammonia level (using ammonia strips) of at least 6 mg/l (another indicator of sewage). The sewage flowed for approximately 5 feet on the street and then flowed into a storm water catch basin, that leads to the Quebrada Juan Méndez (East Branch) about 30 feet away. EPA poured dye powder into the sewage flow as it entered the stormwater catch basin and within minutes the dye came out in Quebrada Juan Méndez (See Photos 218, 219 and 230-235). Proving that the sewage was discharging into the Quebrada Juan Méndez via a stormwater outfall.

The sewage flowing on the street is within 500 feet of a hospital and a school and is adjacent to a grocery store and poses a health risk to pedestrians in the area. People that we spoke to in the area said that this overflow has been occurring for twenty years and has not been abated. EPA Region 2 CEPD followed up with PRASA after

the inspection. PRASA reported that the discharge had been abated. PRASA must provide a summary of the cause of the problem, what was done to correct it and what is being done to avoid recurrence of this problem.

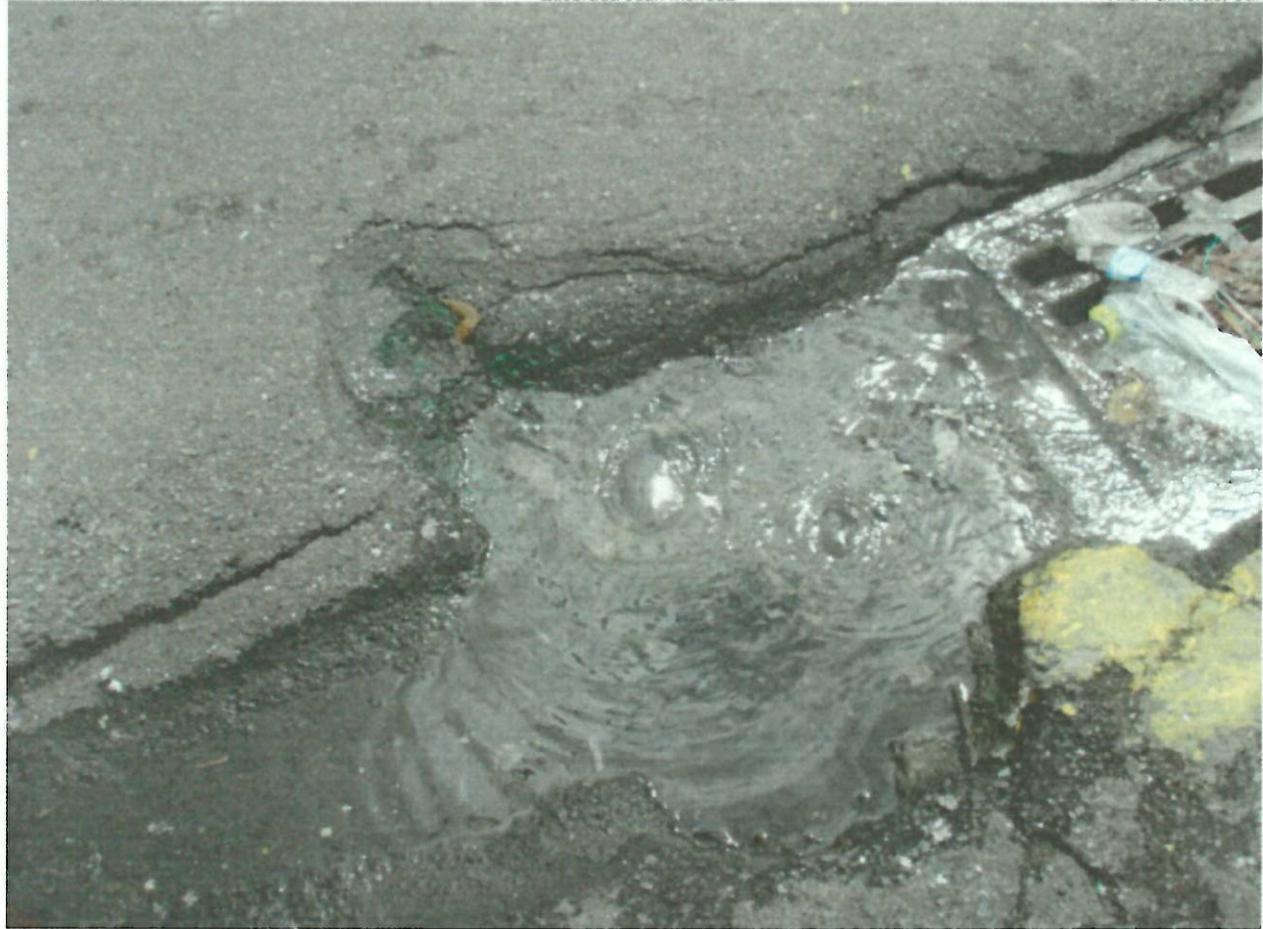
P2160222.JPG

P2160221	Photo of sample jug and rope.
P2160222	Sewage flowing out of Lealtad street/near Ave. José De Diego and into a stormwater catch basin which flows to Quebrada Juan Méndez - approx 30' away.
P2160223	Sewage flowing out of Lealtad street/near Ave. José De Diego and into a stormwater catch basin which flows to Quebrada Juan Méndez - approx 30' away.
P2160224	Photo of sign stating "Bienvenidos Urbanización Victoria" at Calle Lealtad across the street from where sewage was flowing out of the street and into stormwater catch basin.
P2160225	Sewage flowing out of Lealtad street/near Ave. José De Diego and into a stormwater catch basin which flows to East Branch of Quebrada Juan Méndez - approx 30' away.
P2160226	NO DESCRIPTION
P2160227	Grocery store with pool table adjacent to the area where sewage is flowing into stormwater catch basin at Lealtad and José De Diego.
P2160228	Sanitary sewer manhole at Calle Lealtad and José de Diego is surcharged the wastewater is near the rim of the manhole.
